# Micro-etching is a Must for the Direct Repair of a Fractured Porcelain Veneer

***Images 1-8 demonstrate step-by-step instructions for this common clinical scenario:***

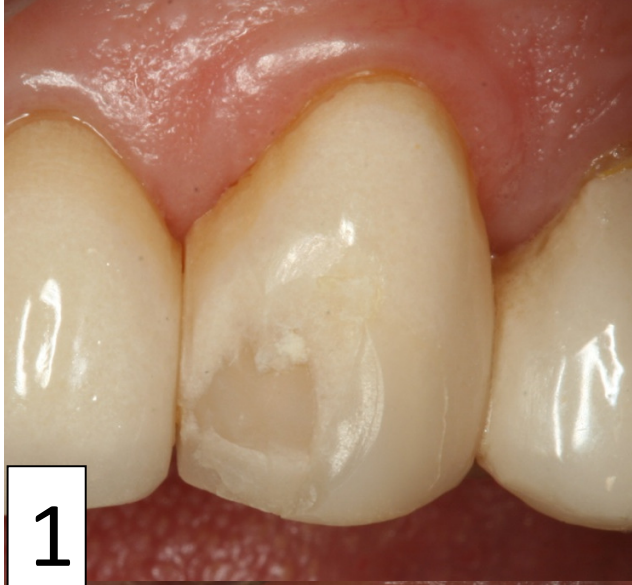
1. The patient had porcelain veneers placed about 12 years ago. She now presents with a fractured veneer at the mesio-facial-incisal aspect of the upper left canine.
